## Schedule of Condition

### Club Energy

Club Energy Otley  
Station Road  
Otley  
LS21 3HX

Sircle  
March 2021

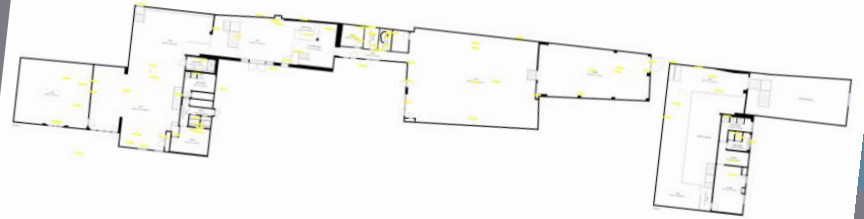
GROSS INTERNAL AREA  
FLOOR 1: 813 m<sup>2</sup>, FLOOR 2: 174 m<sup>2</sup>  
TOTAL: 987 m<sup>2</sup>  
NOTE: AREA AND DIMENSIONS ARE APPROXIMATE, ACTUAL MAY VARY
